Horz. Stab troubles

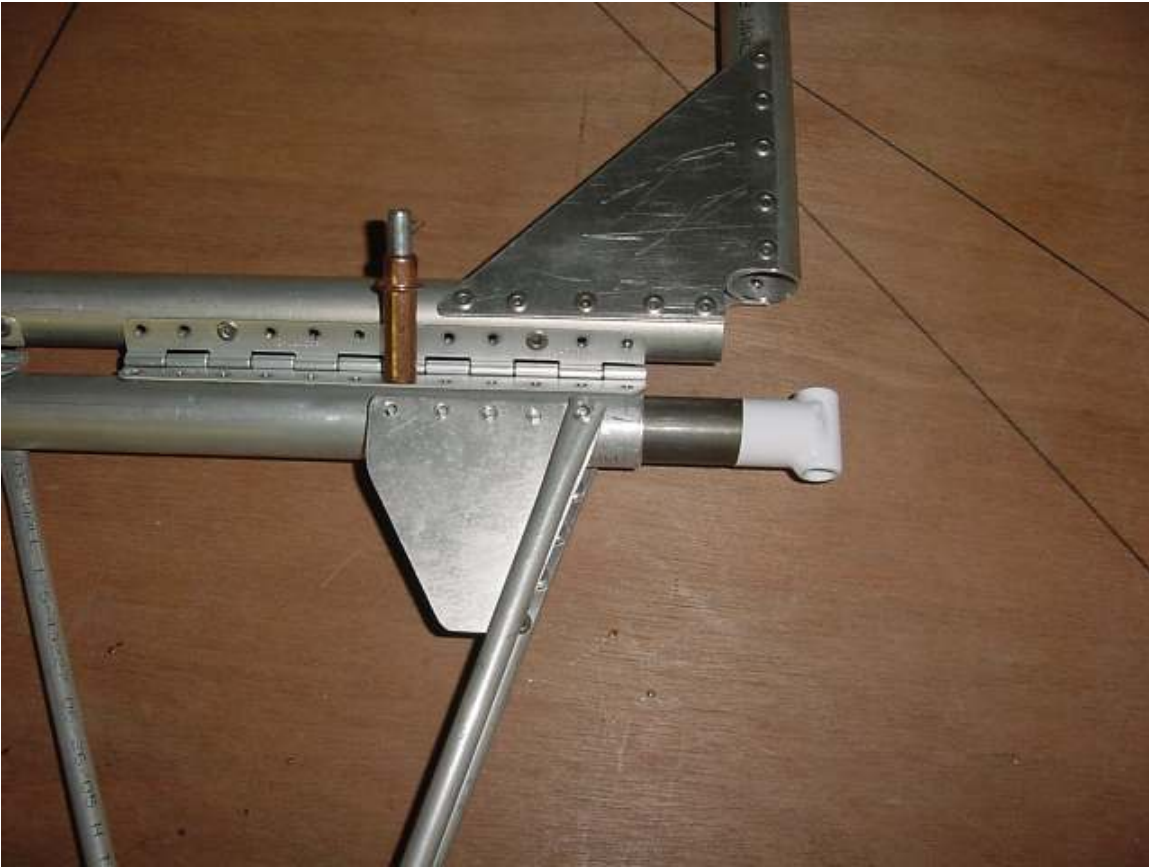
The plans show a .875 difference in length between the horz. stab TE and elevator LE so that's how they were built. Unfortunately the plans are wrong as this makes the LE too short to properly mount the elevator control horn .

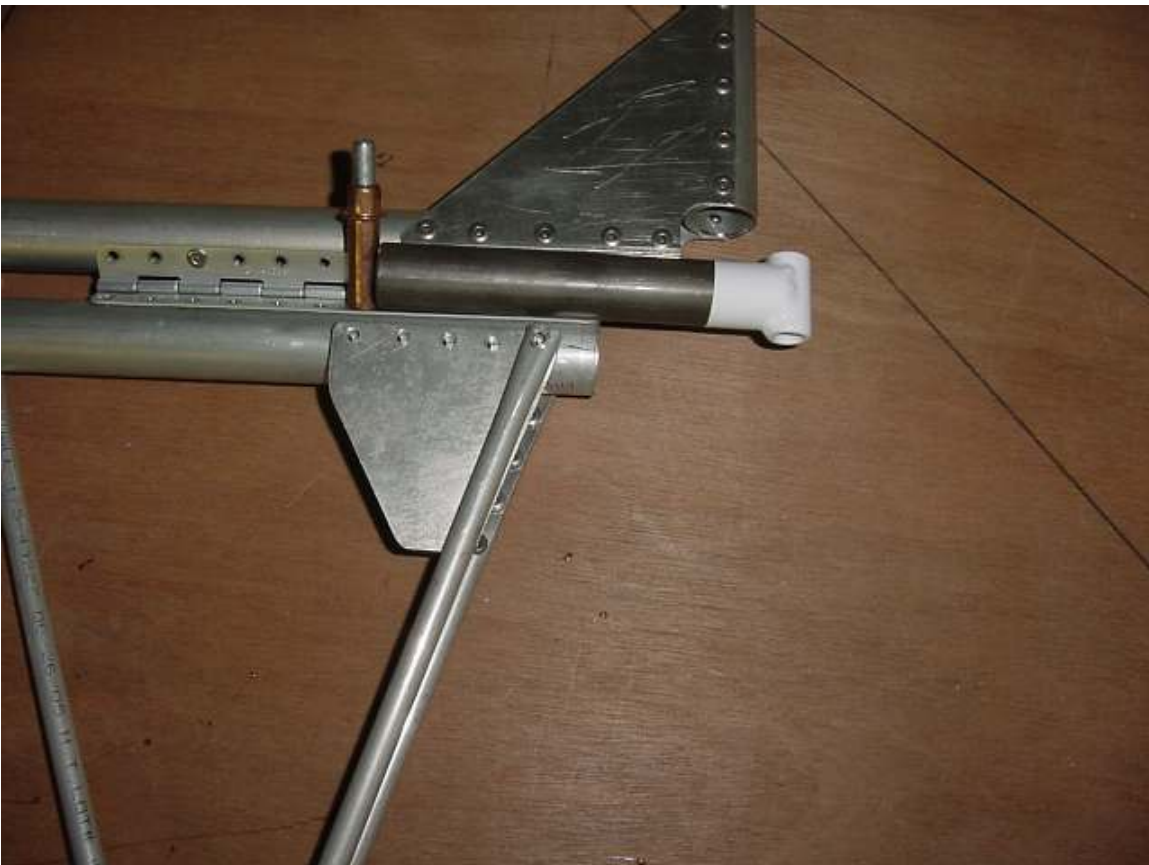
So we attempted to replace just the LE of the elevator but we are unhappy with the damage being done to the ribs from drilling out the rivets. I guess building new elevators is our best option. ☹
